The reason for red streaks on dermoscopy in the distal part of a subungual hemorrhage

Citation: Sato T, Tanaka M. The reason for red streaks on dermoscopy in the distal part of a subungual hemorrhage. *Dermatol Pract Concept*. 2014;4(2):18. <http://dx.doi.org/10.5826/dpc.0402a18>

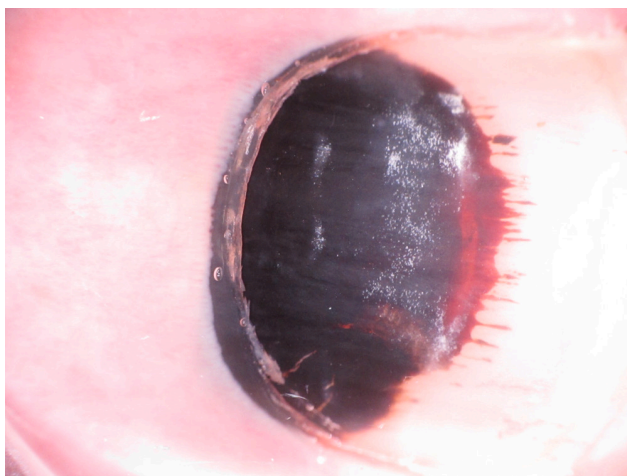
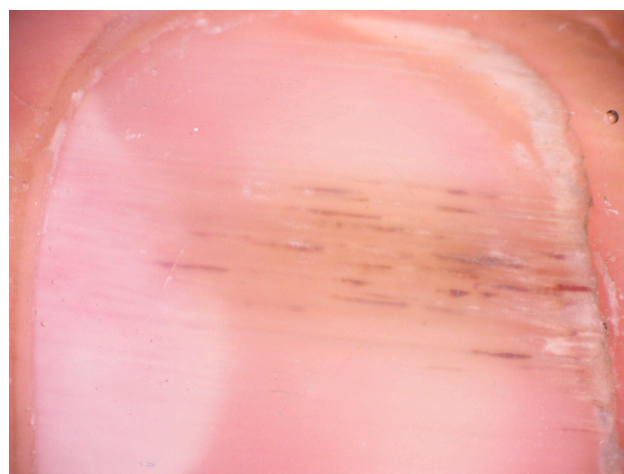
Figure 1. (A) Dermoscopy of a subungual hemorrhage revealed that the proximal end of the hemorrhage is round, whereas the distal end is characterized by a streaks-like or filamentous pattern. (B) Dermoscopy revealed numerous splinter hemorrhages in a case of chronic/minor trauma caused by walking. [Copyright: ©2014 Sato et al.]

hemorrhage generally demonstrates well-circumscribed reddish dots and lacunas, or a homogeneous area in the proximal area of the nail, and streak-like structures and linear pattern in the distal edge, depending on the time, location, and volume of bleeding (Figure 1A, B). Here, we discuss the reasons for the streak-like structures and linear patterns on

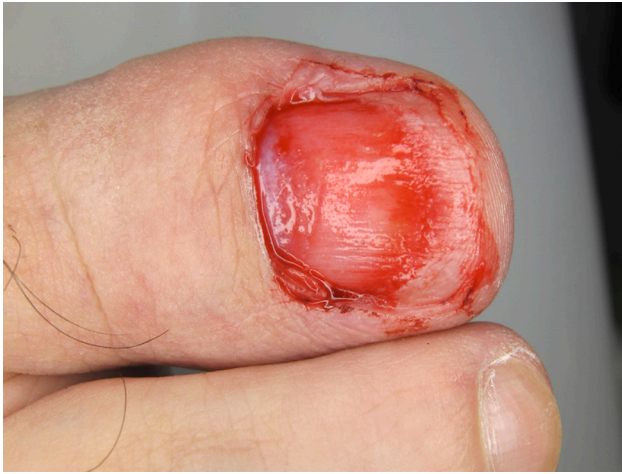
Figure 2. Clinical picture of a nail avulsion injury. The lunula and nail bed were exposed; the lunula was pinkish-white in color with a smooth surface. The nail bed was bright red in color and revealed a pattern of longitudinal dermal ridges stretching from the lunula to the distal groove. [Copyright: ©2014 Sato et al.]

distal end of the lunula and ended at the distal groove. The numerous dermal papillae seemed to run in parallel to each other (Figure 2). The wound was treated by application of a sheet of artificial dermis.

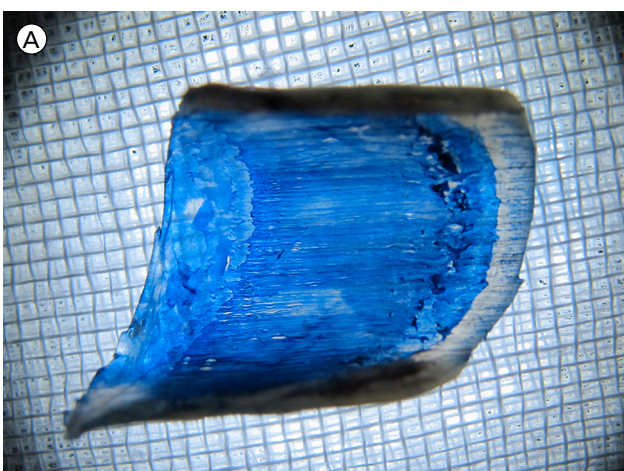
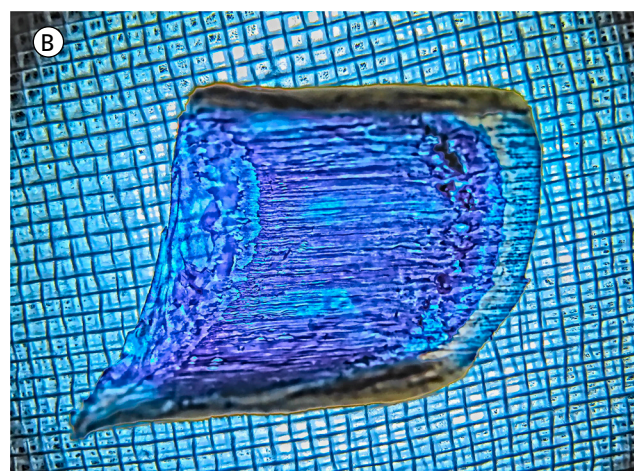
Figure 3. (A) The ventral surface of the removed nail plate was stained with Parker Quink Permanent Blue-Black ink. The area of the lunula, the nail bed, the hyponychium, and free edge of the ventral surface of the nail plate are clearly seen.

(B) High dynamic range image conversion was performed for the image of the ventral surface of the nail, and the differences between the nail parts were more clearly recognized. [Copyright: ©2014 Sato et al.]

The removed nail plate was stained with Parker Quink Permanent Blue-Black ink for the purpose of structural observation. A picture of the ventral surface of the nail was taken, and a high dynamic range (HDR) image conversion [2] was performed (Figure 3A, B). The ventral surface of the nail plate was stained well, and the lunula, the nail bed, the hyponychium, and the free edge were sharply distinguished. The lunula showed a structureless flat area, and the nail bed demonstrated numerous longitudinal parallel fissures and ridges, forming parallel lines. The hyponychium showed less prominent longitudinal lines, and the free edge of the nail demonstrated narrower, dense lines. These findings were consistent with those of Berker et al [3]. In the transverse (sagittal) section of adult fingers at the nail bed, a tongue-and-groove arrangement of papillary dermal papillae and epidermal rete ridges can be observed microscopically [4], and these complementary structures correspond to a serrated interdigitation of the ventral surface of the nail plate and nail bed [4]. Hasegawa et al. [5] and Sangiorgi et al. [6,7] studied the microvasculature under the nail plate using corrosion casting, stereoscopic microscopy, and scanning electron microscopy, and found no capillary loops at the nail matrix region. Instead, a single, layered, rectangular plexus of capillaries under the plane of the nail matrix was observed. In the nail bed, they observed numerous capillary loops arising from a deeper regular arrangement of sagittally aligned, parallel rows of vessels. We have tried to describe the anatomy of the microvasculature under the nail plate based on the observa-

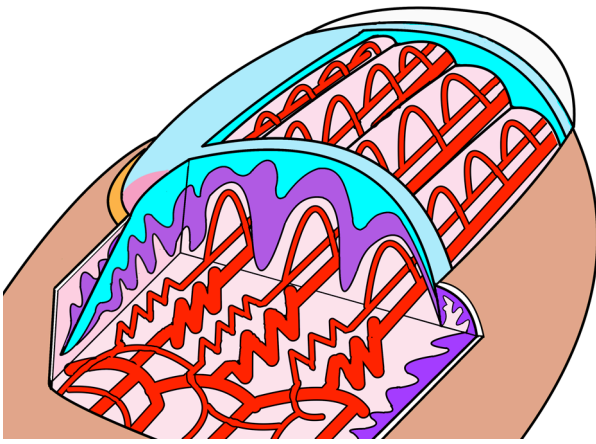
Figure 4. Anatomical illustration of the microvasculature under the nail plate. No capillary loops are present at the nail matrix region. A single, layered, rectangular plexus of capillaries can be found under the plane of the nail matrix. In the nail bed, numerous capillary loops are observed arising from a deeper regular arrangement of sagittally aligned, parallel rows of vessels. [Copyright: ©2014 Sato et al.]

tions described in these three papers (Figure 4). Subungual hemorrhage occurs due to ruptures of the capillaries under the lunula and/or the nail bed by external force to the nail plate. As the surface of the lunula is flat, the hemorrhage around the lunula becomes a round lacunas or homogeneous area because of the surface tension of blood. When a certain amount of blood reaches the nail bed, the proximal end of the blood lagoon is still round, but the distal end of it shows
